1.0 Bluewater

Bluewater Site Long-Term Custody Compliance Requirements

Bluewater Site Inspection Results

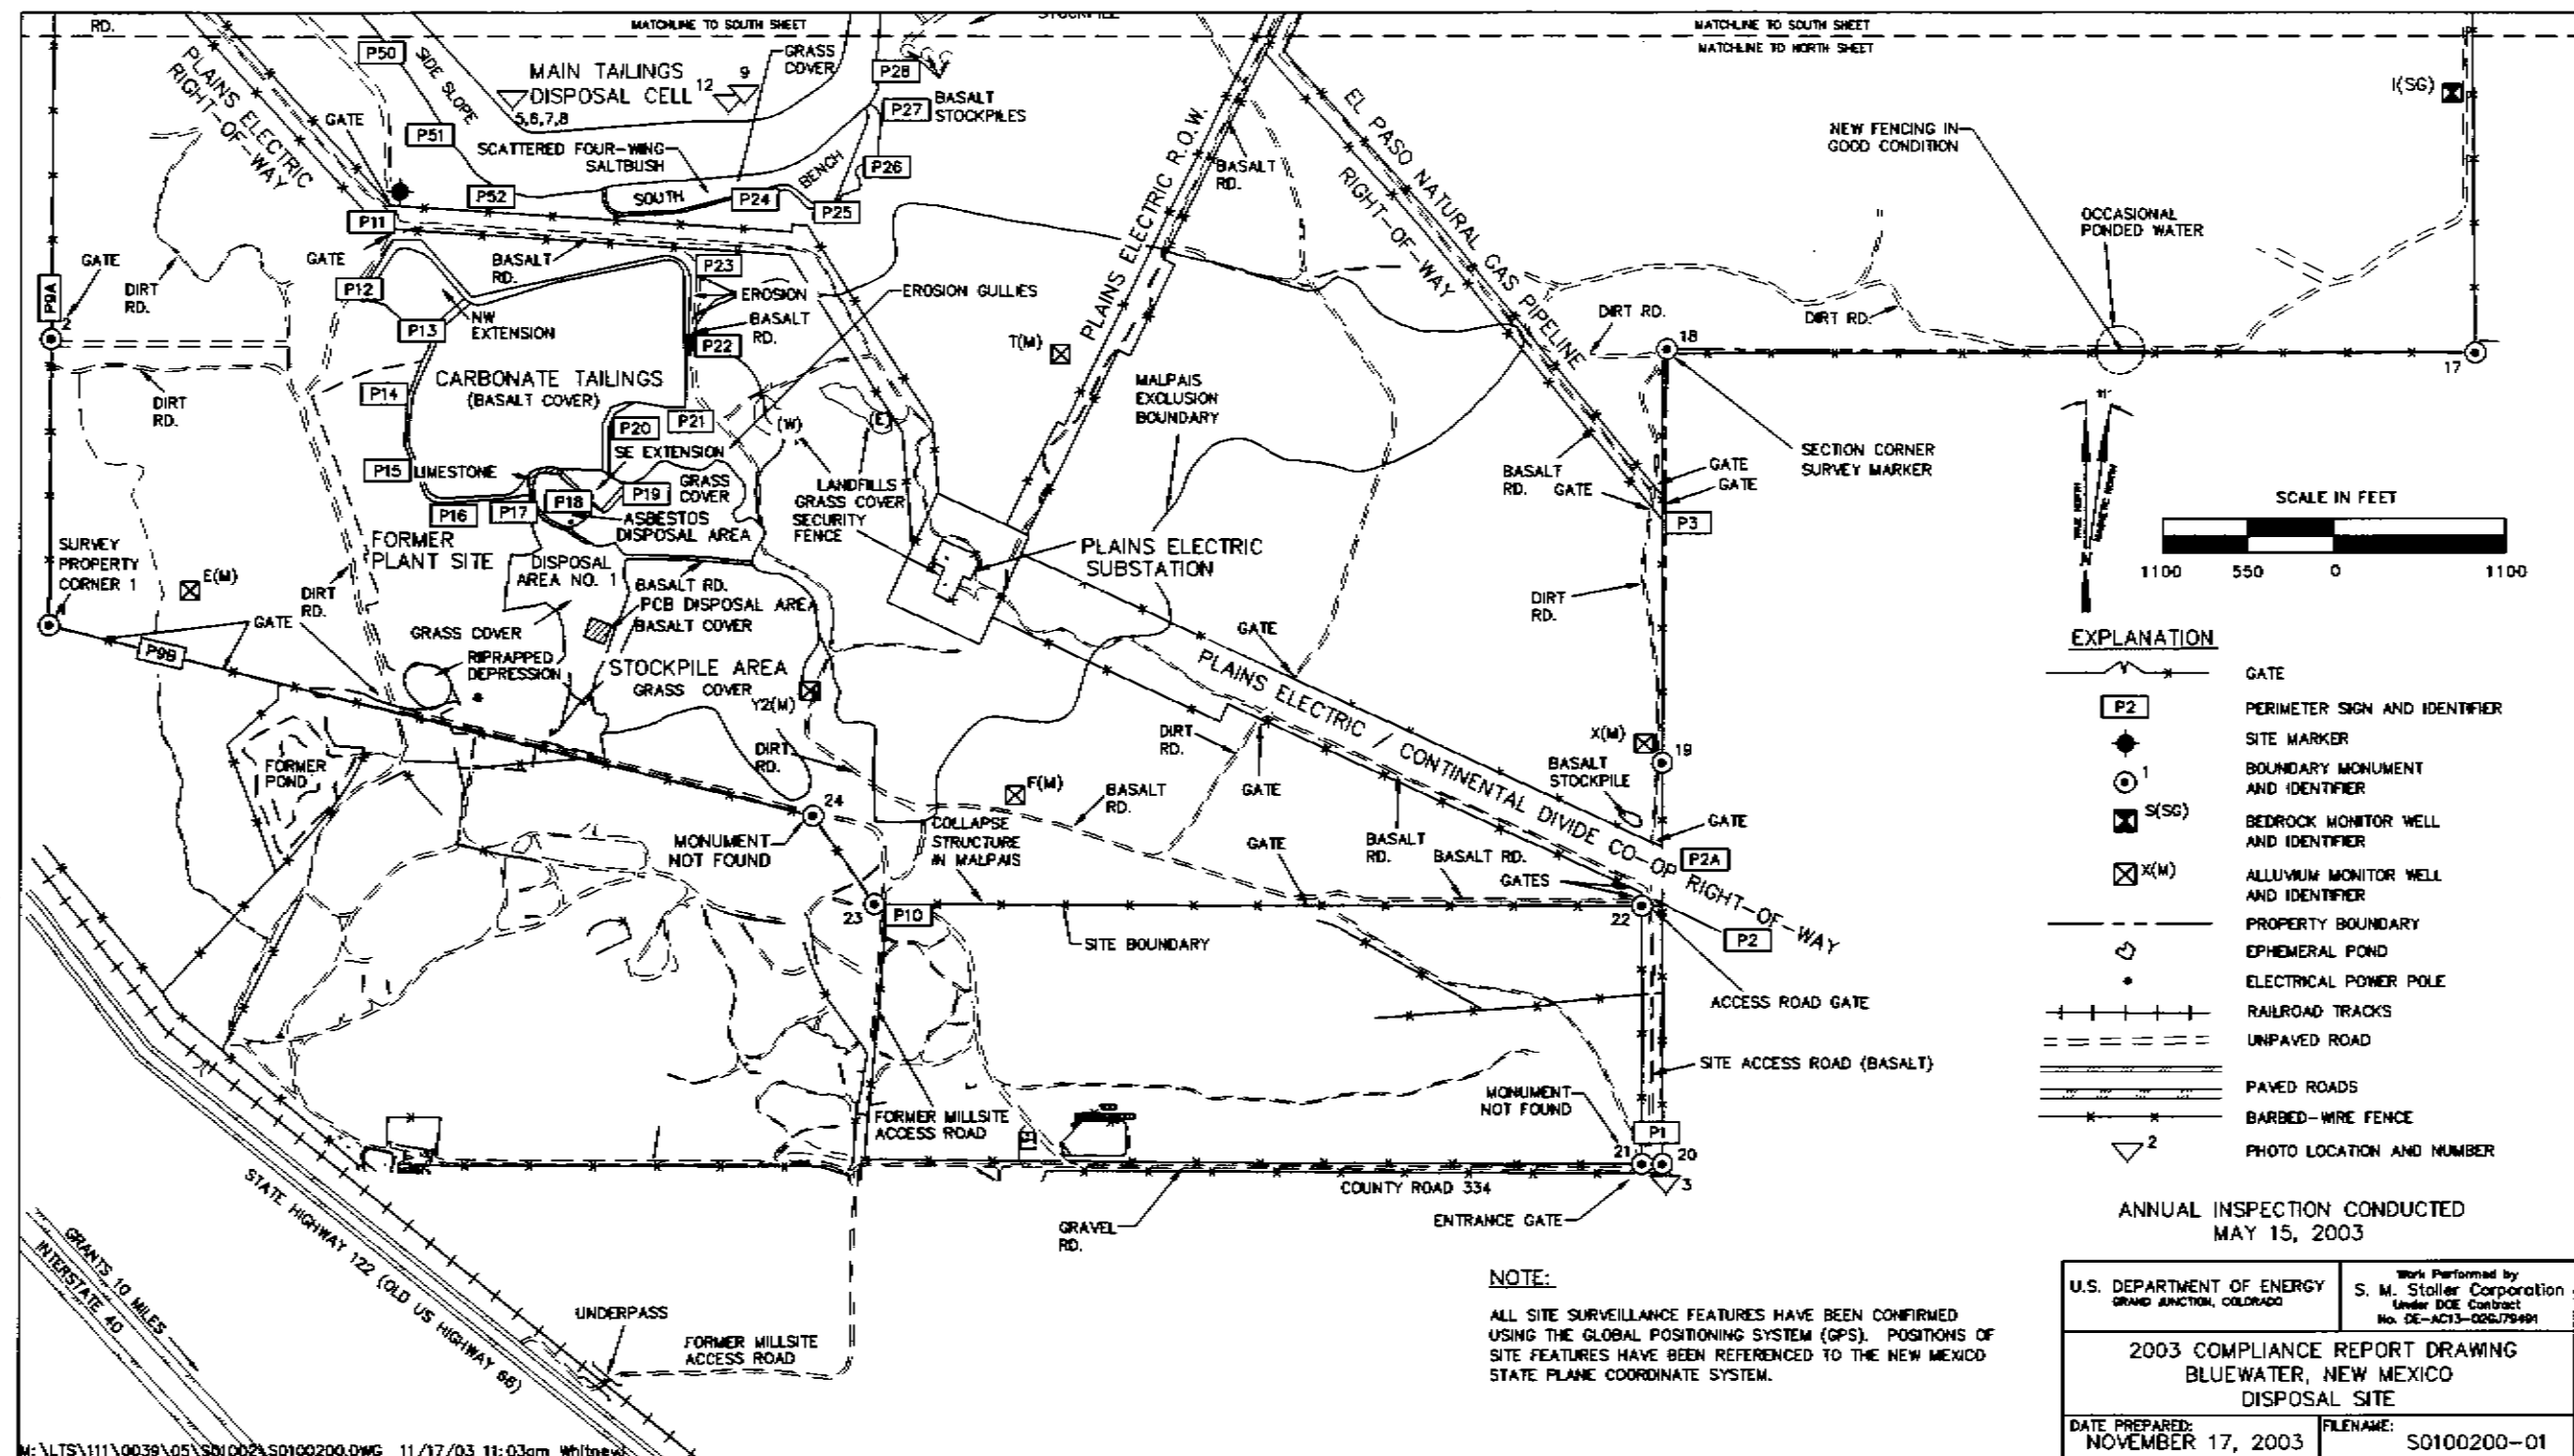
Figure 1-1. Bluewater, New Mexico, South Area, 2003

An electric power substation is enclosed by a security fence near the center of the site along the Plains Electric Company right-of-way (Figure 1-1). Fencing around this station generally is in good condition.
